Electromagnetic and Magnetic Surveys at Dunn Field, Defense Depot Memphis, Tennessee

by Janet E. Simms

U.S. Army Corps of Engineers Waterways Experiment Station 3909 Halls Ferry Road Vicksburg, MS 39180-6199

Final report

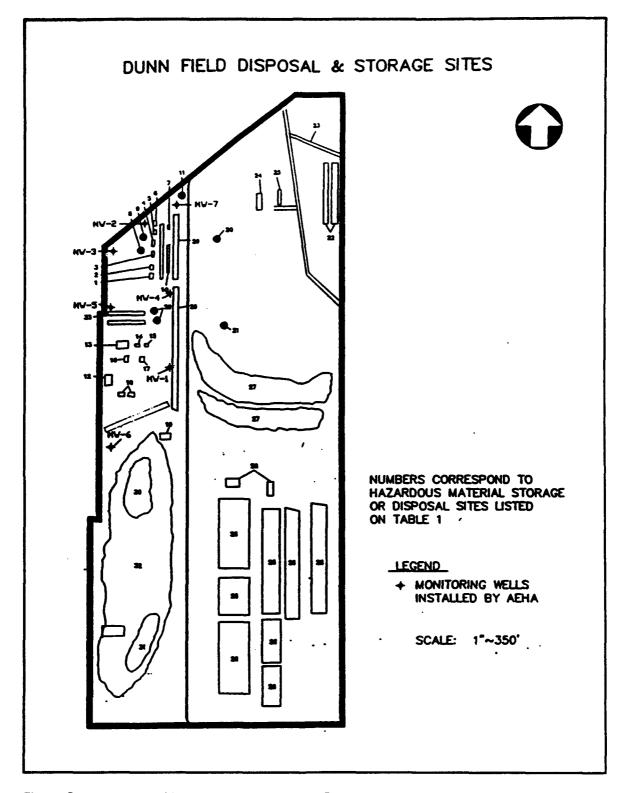
Figure 3. Location of known disposal sites at Dunn Field

DDMT consists of two sections, the main facility and Dunn Field, a storage area about 70 acres in size (Figure 2). Much of the waste disposal activities at DDMT were conducted at Dunn Field. Figure 3 and Table 1 show the locations of known disposal sites in Dunn Field and list the types of material buried. (In Figure 3 the disposal sites in the northwest region of Dunn Field are numbered based on a DDMT Post Engineer map (Office of the Post Engineer 1984). There is a discrepancy between this figure and Figure 1-2 of the Feasibility Study Final Report (U.S. Army Engineer Division, Huntsville 1990). Figure 1-2 does not show burial trench 10 but has burial trench 30 located in the same vicinity. Also, Figure 1-2 has burial pits 6 and 8 interchanged.)

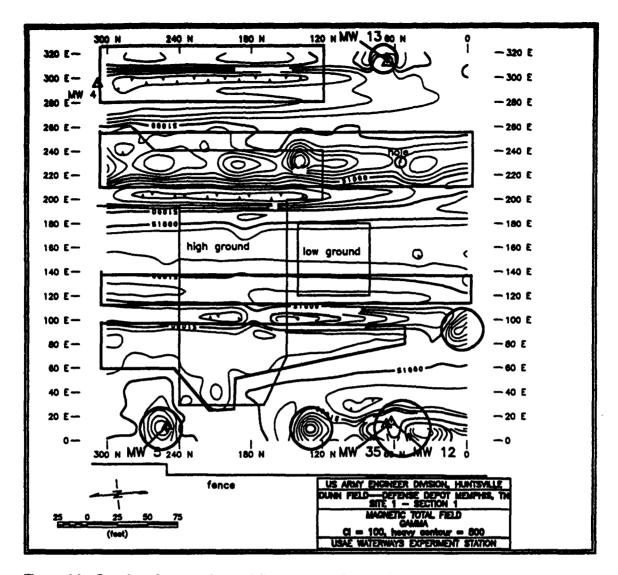
Figure 11. Results of magnetic total field survey, Site 1, Section 1

The site location map showing the surface and cultural features for Section 1 is given in Figure 10. The magnetic and EM-31 data for this section are plotted in Figures 11-14. The magnetic total field data indicate several anomalous areas which are outlined by a heavy solid line (Figure 11). Three of the anomalies correspond to the locations of Monitor Wells (MW) 12 and 35 (65N, 10E), MW 5 (250N, 10E), and MW 13 (65N, 310E). Two small anomalies are indicated at (130N, 10E) and (5N, 90E). A moderately high linear anomaly is bounded by (60N, 85E), (210N, 30E), (300N, 60E), and (300N, 90E). Disposal sites (DS) 13-17 and 33 (Figure 3) are located within this anomalous area (145N-250N). Another moderately high linear anomaly extends from (30-300N, 120-130E). There is no known disposal site in this area. A strong linear anomaly extends from (0-300N, 220-250E) and shows five isolated anomalies within it. This linear anomaly corresponds to the location of DS 18 (Figure 3). The weak high at (0-300N, 190E) may mark the edge of DS 18 since the site is stated to be 45 ft wide (Office of the Post Engineer 1984). A magnetic high-low is located at (90-300N, 270-320E) and corresponds to Area C on DDMT Post Engineer drawings (Office of the Post Engineer 1984) or DS 29 (southern one) in Figure 3.

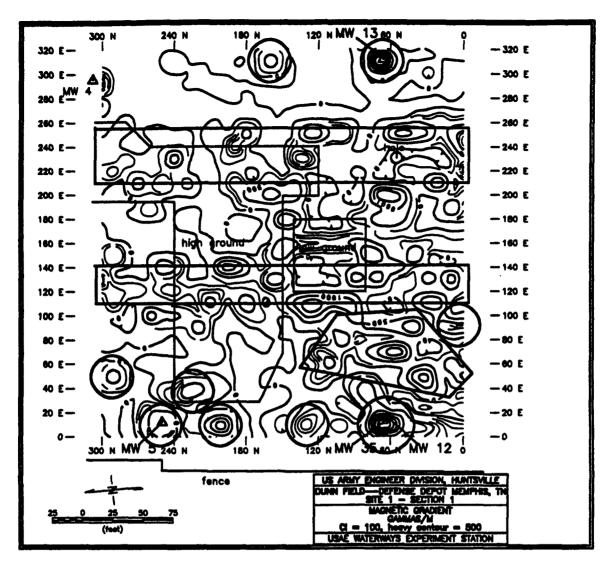
Figure 12. Results of magnetic gradient survey, Site 1, Section 1

The magnetic gradient data are plotted in Figure 12 and show many small anomalies covering much of the area. Many of the anomalies correlate with the magnetic total field anomalies. Additional anomalies include (200N, 10E), (290N, 50E), (0-120N, 40-100E), and (160N, 310E).

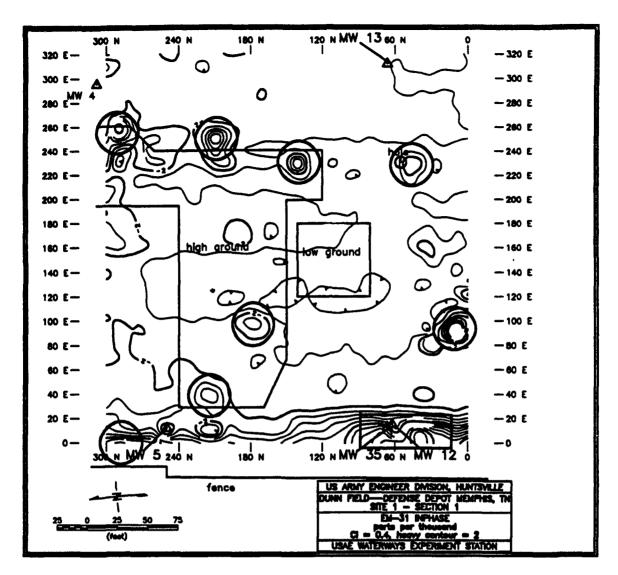
Figure 14. Results of EM-31 inphase survey, Site 1, Section 1

The EM-31 inphase data (Figure 14) show isolated high anomalies along (50-300N, 220-260E) corresponding to DS 18. Other highs are at (10N, 90E), (60N, 10E) (MW 12 and 35), and in the northwest corner (fence). Moderate highs are seen at (220N, 40E) and (180N, 100E). A broad low tends to outline the location of the magnetic gradient anomalies in the central region of

the section and also bounds the linear highs seen on the total magnetic field plot.

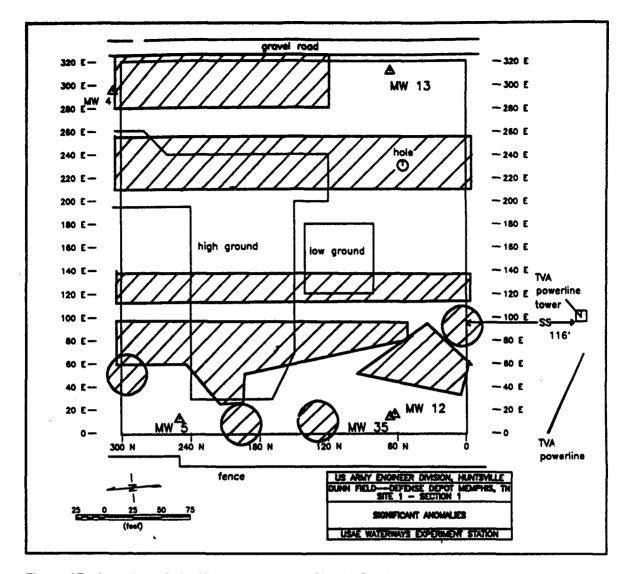
Figure 15. Location of significant anomalies, Site 1, Section 1

The majority of anomalies identified in Section 1 correspond to known cultural features and known disposal trenches and pits. These anomalous areas probably contain some ferrous material. Figure 15 is a generalized map showing the location of identified anomalies, excluding those due to cultural features. Table 2 gives the location and description of all anomalies. The columns labeled T, G, C, and I correspond to the components measured by the magnetometer and EM-31: magnetic total field, magnetic gradient, conductivity, and inphase, respectively. An 'x' in one of these columns indicates that an anomaly was identified on the respective contour plot. If an 'x' is marked in either the T or G column, this indicates that something, which may or may not be metallic, in the subsurface is generating an anomalous magnetic response. An 'x' in the C column identifies a location having a conductivity significantly different from background values, which could be caused by varving soil or groundwater conditions, or the presence of foreign objects. If an 'x' is marked in the I column, then this suggests that the anomaly is due to a metallic object. An 'x' in all four columns gives a strong indication that a magnetic, metallic object is present in the subsurface.

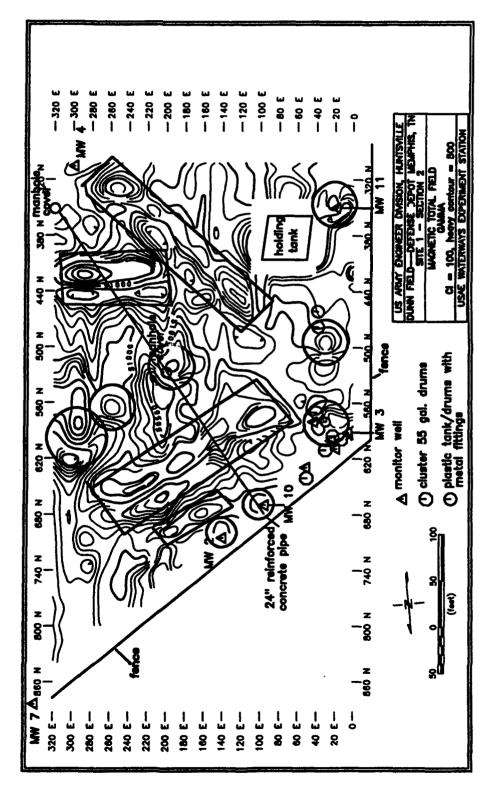
Figure 17. Results of magnetic total field survey, Site 1, Section 2

The isolated magnetic total field anomalies (Figure 17) along the western and northern boundary of the section are due to monitor wells and/or 55 gallon drums (350N, 20E), (500N, 35E), (560-600N, 0-40E), (670N, 100E), and (700N, 140E). The anomaly at (520N, 200E) is caused by a manhole cover. The anomalies at (560N, 260E) and (590N, 300E) are within DS 10 and DS 29 (northern one, Figure 3) (Office of the Post Engineer 1984, Area B), respectively. Three anomalies exhibiting linear trends are noted. One trends northwest from (330N, 260E) to (450N, 120E). The eastern end of this anomaly (330N, 260E) also corresponds to the location of the northern end of DS 18. Another linear high extends northeast from (570N, 100E) to (650N, 270-E). There are no known disposal trenches at these locations. The third linear trend is smaller, extending from (430N, 210-320E). Again, there is no known trench here, however this location is between the two linear DS 29 sites in Figure 3 (Office of the Post Engineer 1984, Areas B and C). A smaller magnetic high having a slight linear trend is located at (680-700N, 150-200E) where there is no known burial site.

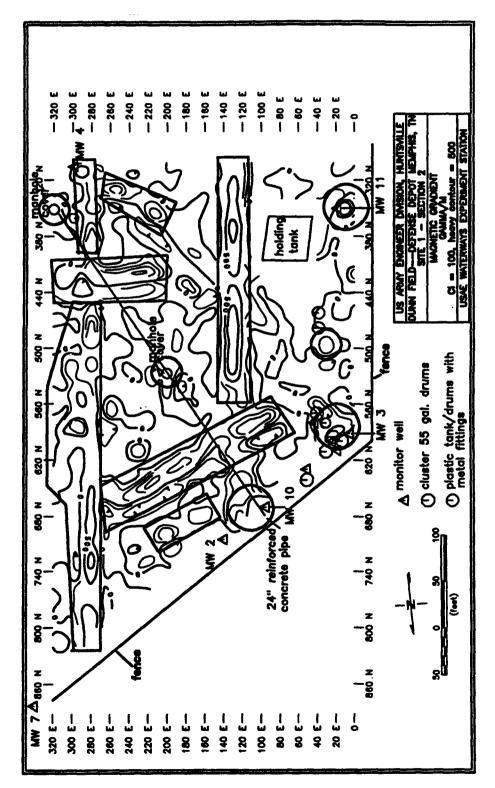
Figure 18. Results of magnetic gradient survey, Site 1, Section 2

A plot of the magnetic gradient data (Figure 18) shows the anomalies due to the monitor wells (350N, 20E), (500N, 35E), (580-600N, 0-30E), ((670N, 100E) and the two manhole covers (520N, 200E), (350N, 320E). Seven linear anomalies are observed, four of which correspond to the magnetic total field

data. The linear high at (470-820N, 270-320E) correlates with the location of DS 7, 10 and 29 (northern one) (Figure 3). The linear high at (300-410N, 280E) corresponds to the northern end of DS 29 (southern one, Figure 3) (Office of the Post Engineer 1984, Area C). The magnetic high at (300-550N, 130E) is in line with DS 8 and DS 9 (approximately 555-575N, 135E and 630-650N, 135E, respectively) (Figure 3) which may indicate the location of an unknown burial trench.

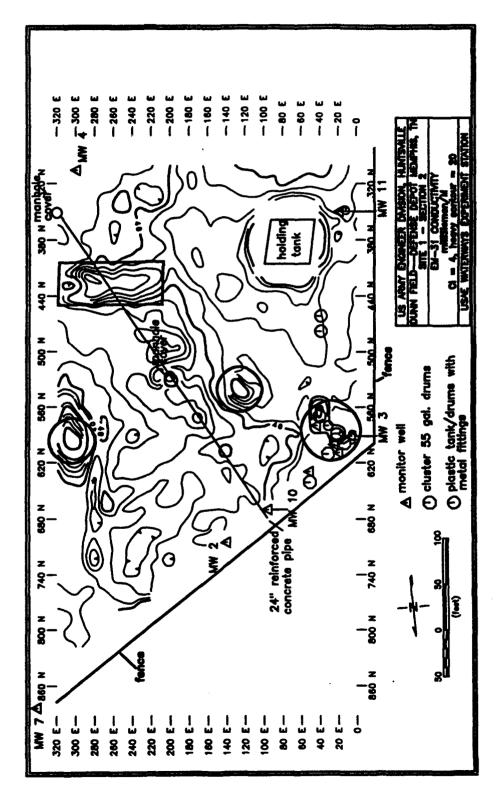
Figure 19. Results of EM-31 conductivity survey, Site 1, Section 2

The EM-31 conductivity data (Figure 19) show a strong low where there is a cluster of monitor wells and 55 gallon drums (560-600N, 0-50E). The conductivity high at (590N, 300E) is within DS 29 (northern one, Figure 3). Another high is at (540N, 125E) which is within a linear magnetic gradient high. The linear high at (430N, 200-300E) correlates with the magnetic highs. The conductivity high directly surrounding the holding tank is due to the tank. The moderate high surrounding that area could be a result of various factors such as 1) the holding tank was leaking, 2) the general westerly flow of surface drainage, or 3) a combined effect due to multiple anomalies within the area as suggested by the linear magnetic highs.

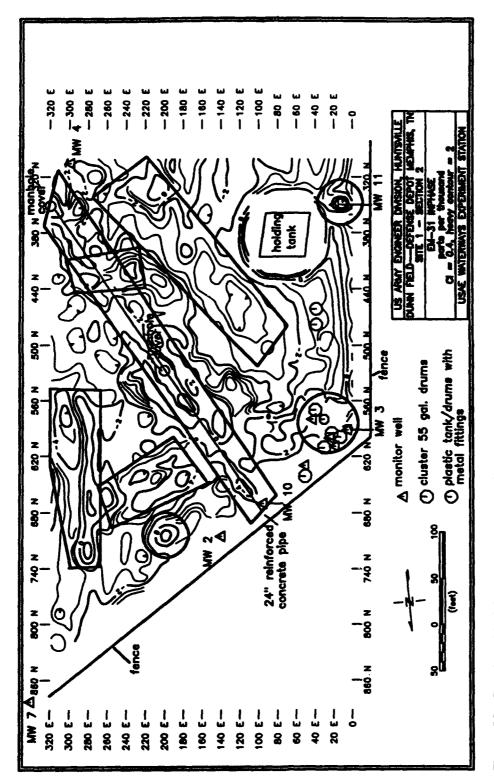
Figure 20. Results of EM-31 inphase survey, Site 1, Section 2

The EM-31 inphase data (Figure 20) detect the reinforced concrete pipe connecting the two manhole covers from (350N, 320E) to (670N, 100E). The anomaly at (350N, 10E) is due to MW 11 and the anomaly at (560-600N, 0-40E) is caused by the cluster of monitor wells and drums. The anomaly high at (550-740N, 260-320E) corresponds to DS 7, 10 and 29 (northern one) (Figure 3). There is an anomaly low at (620-700N, 170-240E) and a high at (430N, 220-280E) which correlate with magnetic anomalies. The high at (330N, 200E) appears to be part of the northwest trend (320N, 260E) to (450N, 100E).

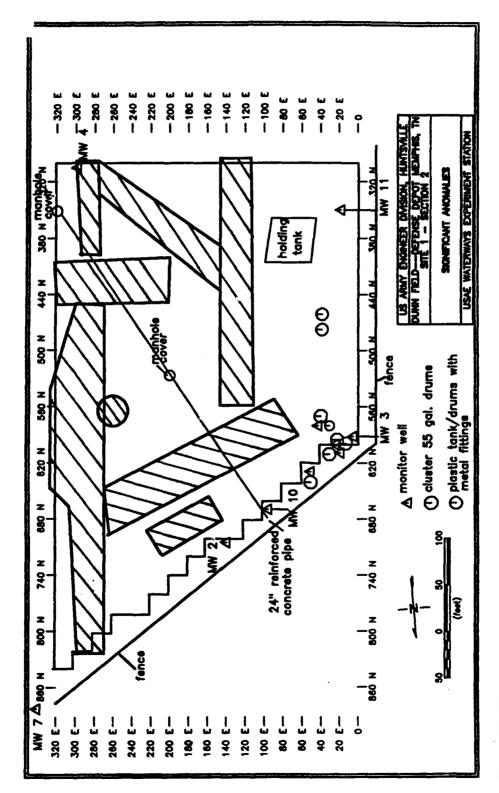
Figure 21. Location of significant anomalies, Site 1, Section 2

The magnetic and EM-31 data collected at Section 2 confirm the location of disposal sites 7, 10, and 29 (north), and also suggest the location of five unknown disposal trenches and pits. Figure 21 is a generalized map showing the location of significant anomalies. The location and description of the anomalies are listed in Table 3.

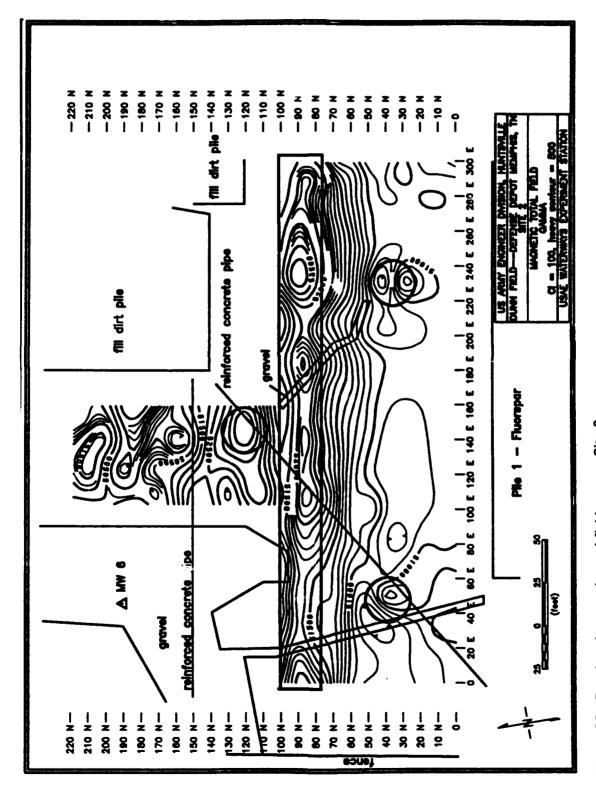
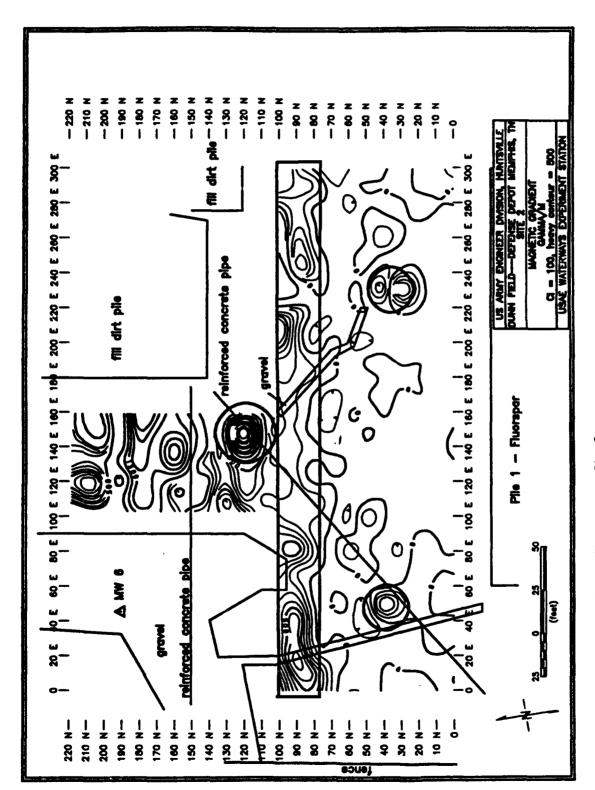
line under which a reinforced concrete pipe lies. An isolated anomaly is located at (230E, 30N) on the magnetic data plots (Figures 23 and 24). The inphase data (Figure 26) show two small anomaly lows at (260E, 40N) and (295E, 30N). A series of high magnetic total field and gradient anomalies extend across the site at (0-300E, 90N). The EM-31 conductivity and inphase data exhibit an anomaly high in the same area at (220-300E, 95N). Figure 27 is a generalized map showing the location of significant anomalies. Table 4 is a summary of the anomalies.

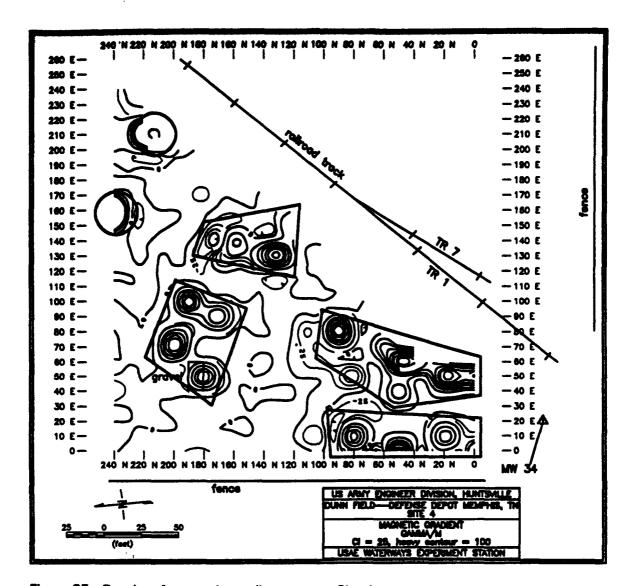
Figure 35. Results of magnetic gradient survey, Site 4

A plot of the magnetic gradient data indicates several anomalous points (Figure 35). The clustering of these anomalies suggests that these areas may be burial pit sites.

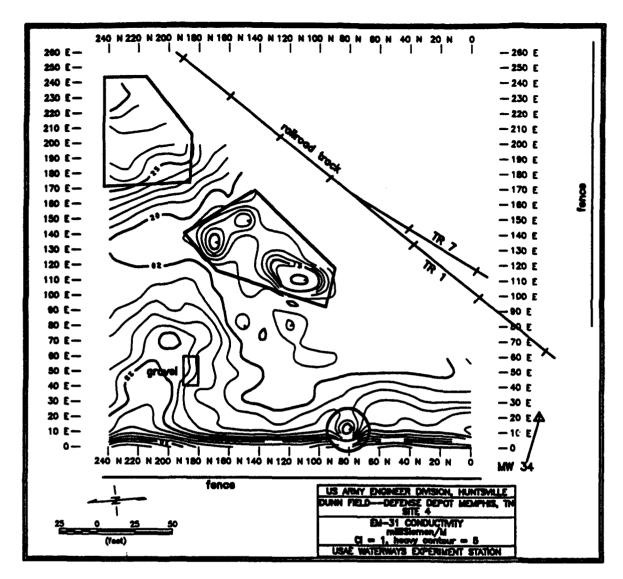
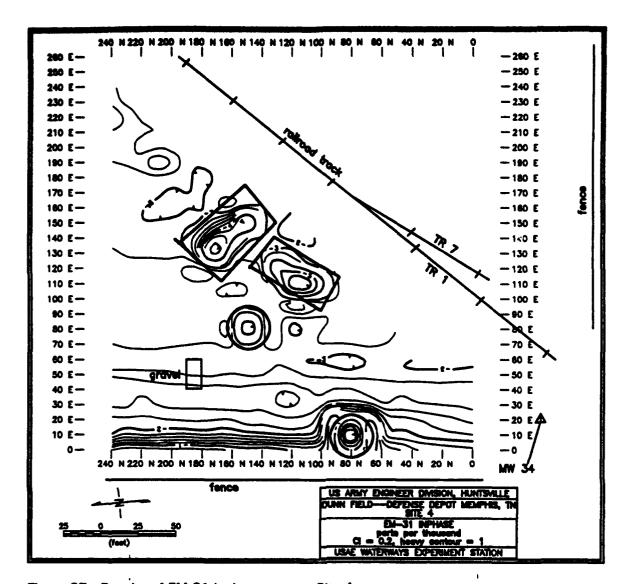
Plots of the EM-31 conductivity and inphase data (Figures 36 and 37, respectively) show anomaly lows at (120N, 110E) and (170N, 140E). These anomalies correspond to anomalies in the magnetic data. The strong high along the western edge of the site is due to the close proximity of the fence. Figure 38 is a generalized map showing the location of significant anomalies. The anomalies are listed in Table 5.

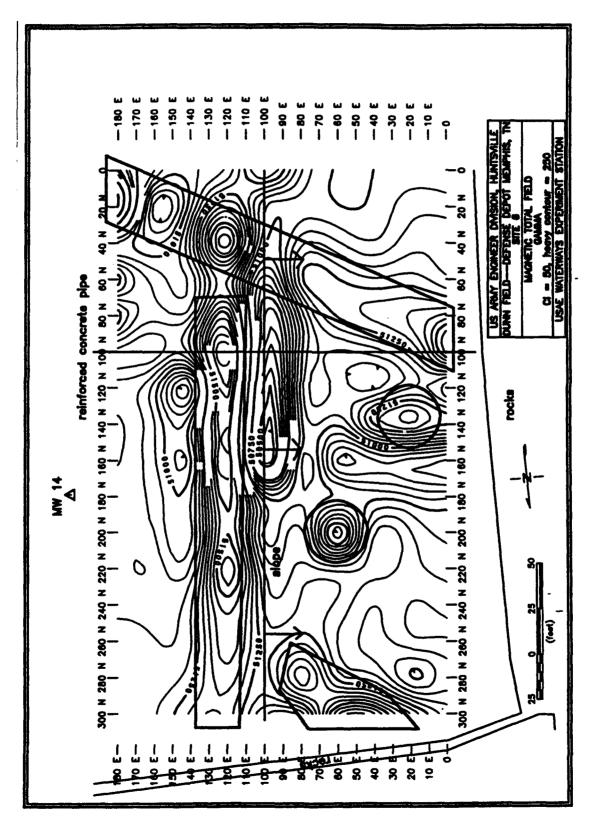
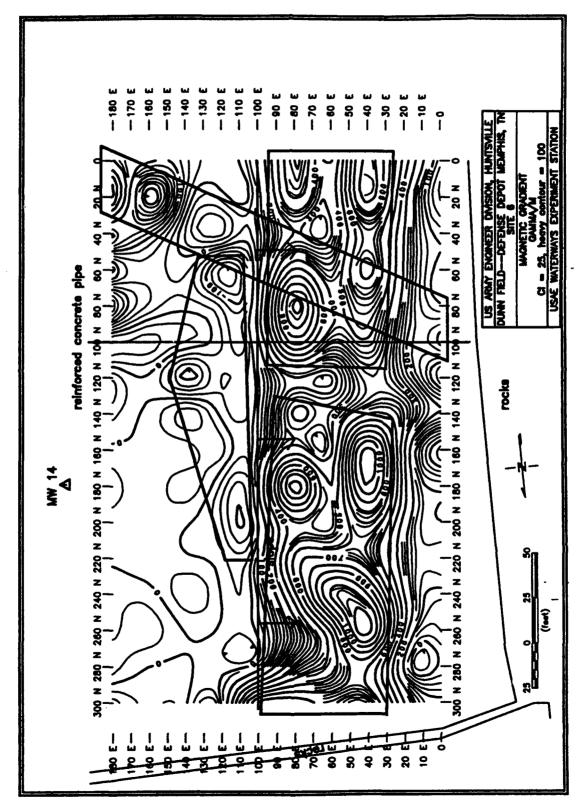
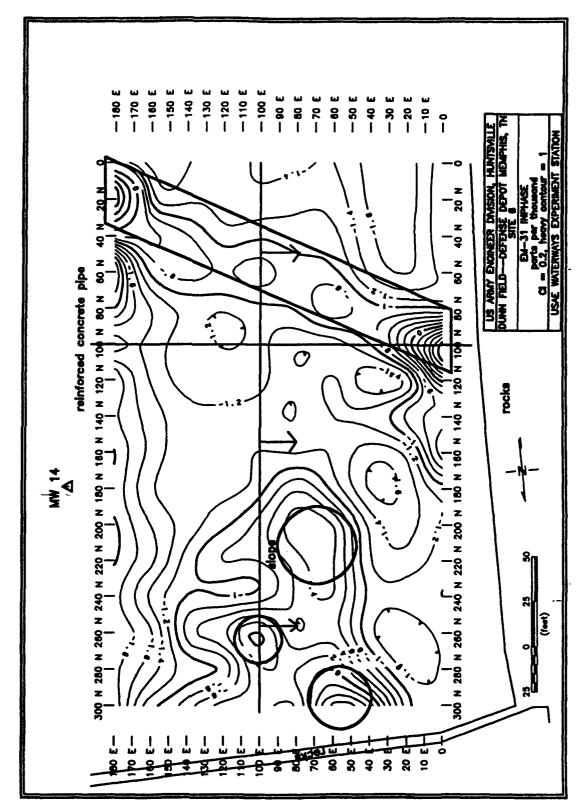
The magnetic total field (Figure 46), magnetic gradient (Figure 47), and EM-31 inphase (Figure 49) plots show that the site has many disturbed areas. A reinforced concrete pipe crosses the site at 100N but these data suggest it runs from (20N, 180E) to (100N, 0E), or this anomaly may represent an unknown disposal trench. The magnetic total field and gradient plots indicate a linear anomaly at (70-260N, 120E). The total field data show an isolated anomaly high at (135N, 20E), low at (200N, 60E), and high at (270-300N, 40-90E). The latter two are also apparent in the magnetic gradient and EM-31 inphase data. Two large areas on the magnetic gradient plot display anomalously high values, (0-100N, 25-90E) and (150-280N, 25-90E). The EM-31 conductivity data (Figure 48) exhibit a gradual increase in conductivity across the site from the northeast to the southwest.

Since this site has been filled and some metallic debris was visible on the surface, it is difficult to state whether any of the anomalies may represent burial trenches or pits. Figure 50 is a generalized map showing the location of significant anomalies. A summary of the anomalies is listed in Table 7.
